Loose Front Door Glass Run

YEAR(S)	MODEL(S)	ADDITIONAL INFORMATION
2010 - 2020	Sienna

Some 2010 – 2020 model year Sienna vehicles may exhibit a condition where the front door glass run on either the right-hand or left-hand side comes loose from the door channel during window operation. Follow the Repair Procedure in this bulletin to address this condition.

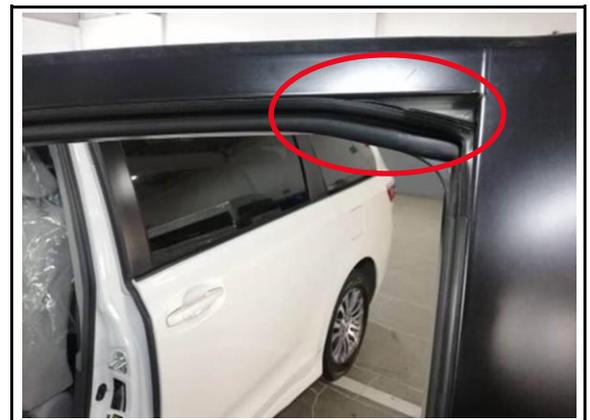
1. Visually inspect the vehicle to confirm the condition exists.
Does the front door glass run on either the right-hand or left-hand side come loose from the door channel during window operation?
 - **YES** — Continue to step 2.
 - **NO** — This bulletin does NOT apply. Continue diagnosis using the applicable Repair Manual.

Figure 1. Front Door Glass Run Failure
